AIRCRAFT ACCIDENT-NS04X

# 382-26 Apr 65

AF Form 711

History of Flight

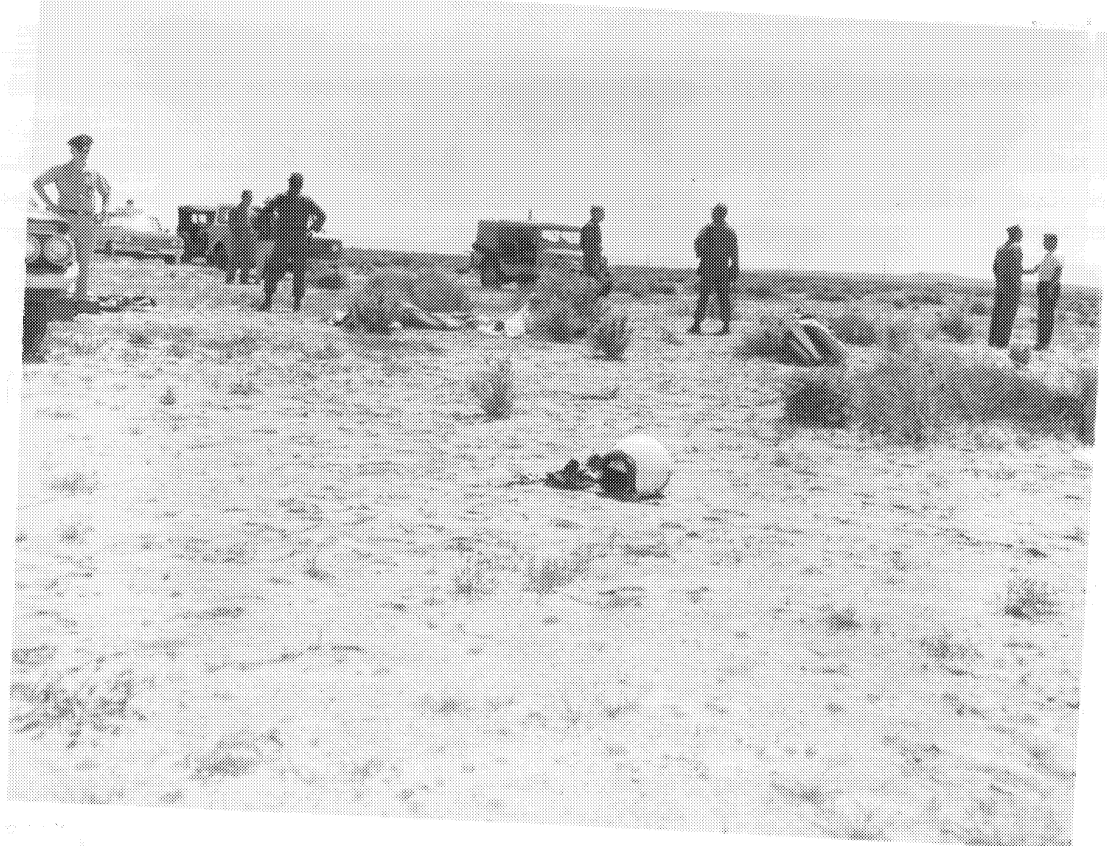
The seat and body were found approximately 108 feet from aircraft impact area. Both had struck the ground forcefully in left posterior-lateral position in close proximity to each other. The pilot's body was found 11 feet from the seat and his parachute was in initial stage of deployment. Parachute deployment had been initiated by the automatic release; the zero delay lanyard was not attached to the parachute D-ring.

SPAT, BODY AND REMAINS TO LEFT SIDE OF AIRCRAFT

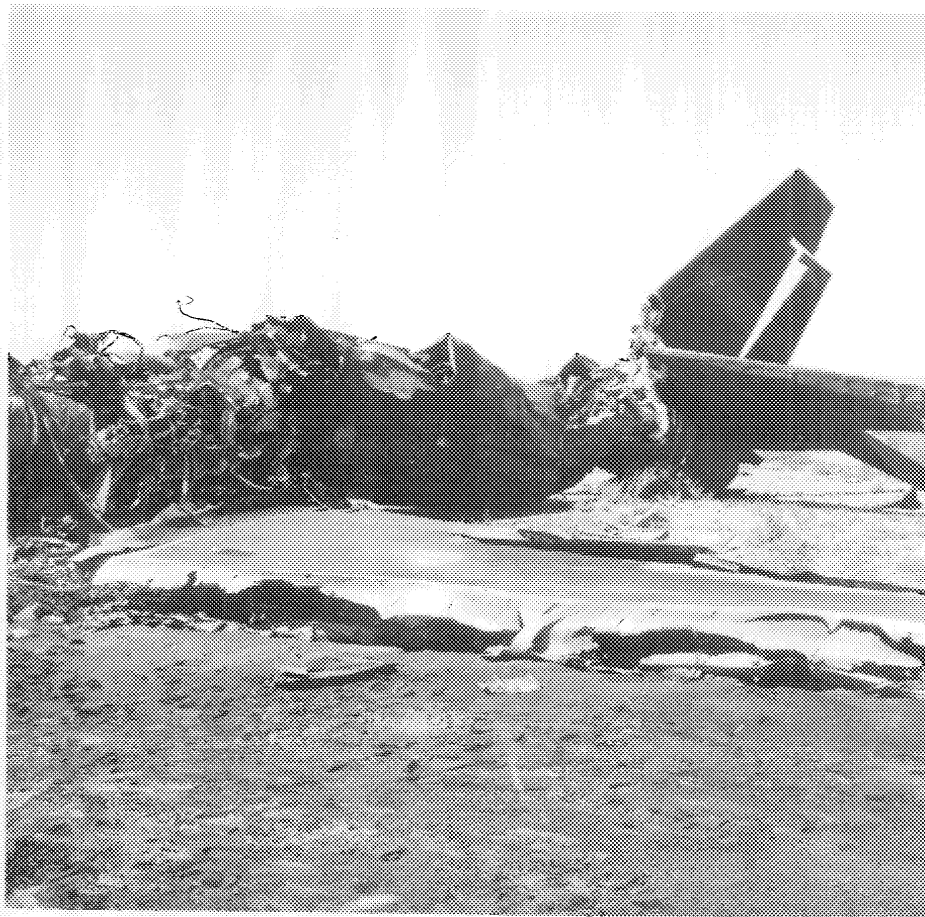
LEFT SIDE IMPACT AREA IN WHICH CRASHWORTHY WAS ORIENTED APPROXIMATELY  
90° TO BEACH AT IMPACT

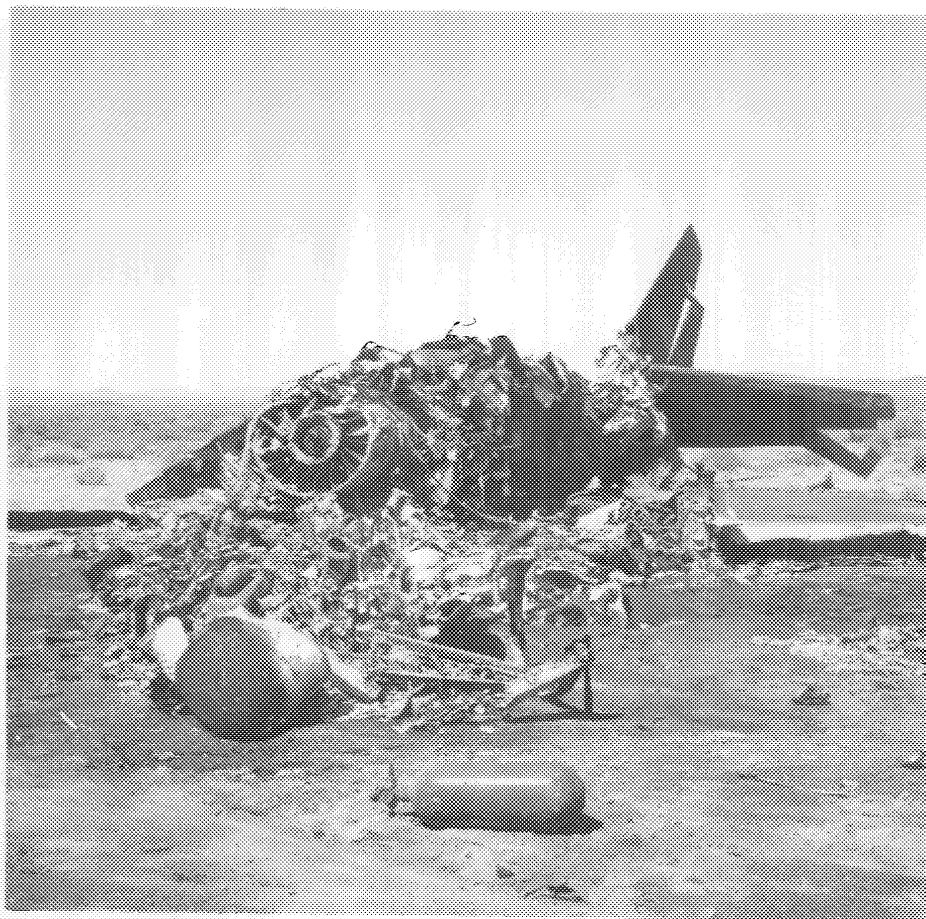
LEFT FRONT VIEW OF DOWNED F-4E AIRCRAFT

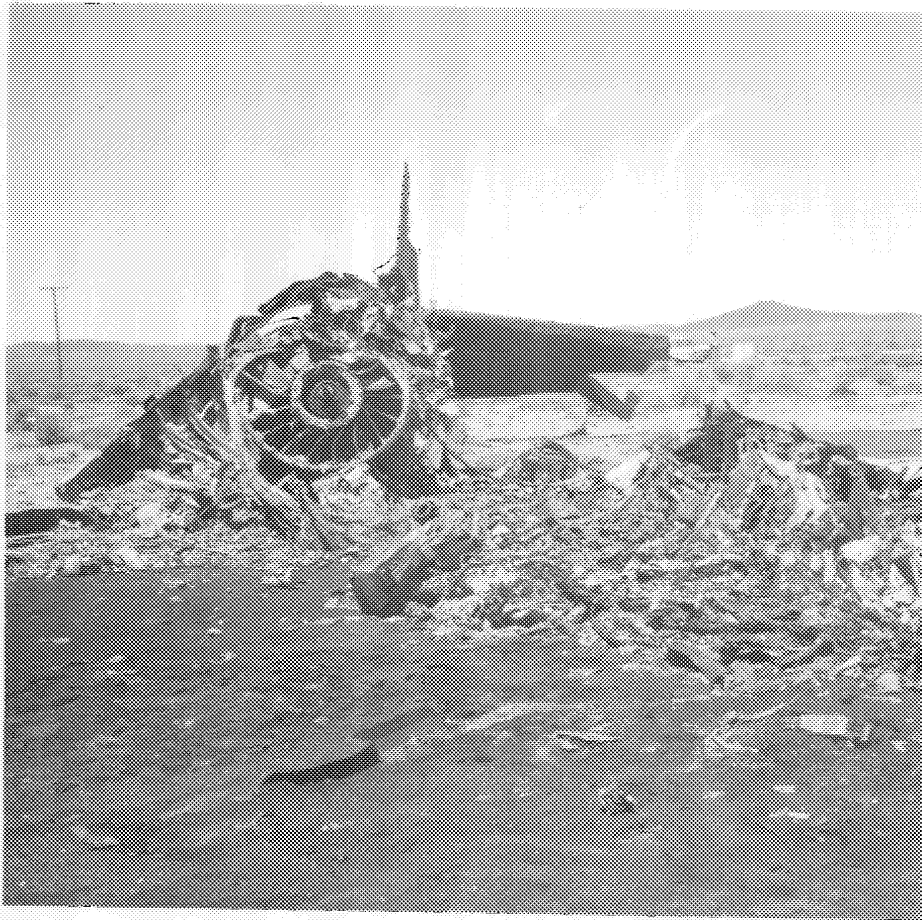
POINT VIEW OF CRASH A: FWD - CRASH LOCATION UNDER POWER IS EVIDENT

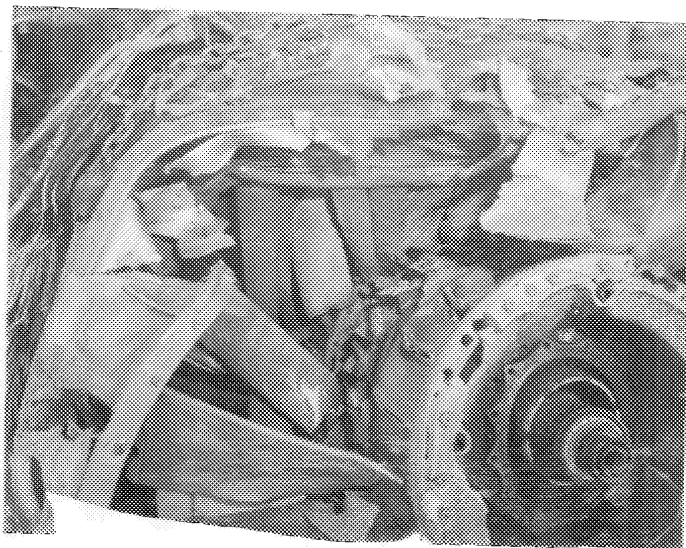
FRONT COMPRESSOR SECTION (TOP)

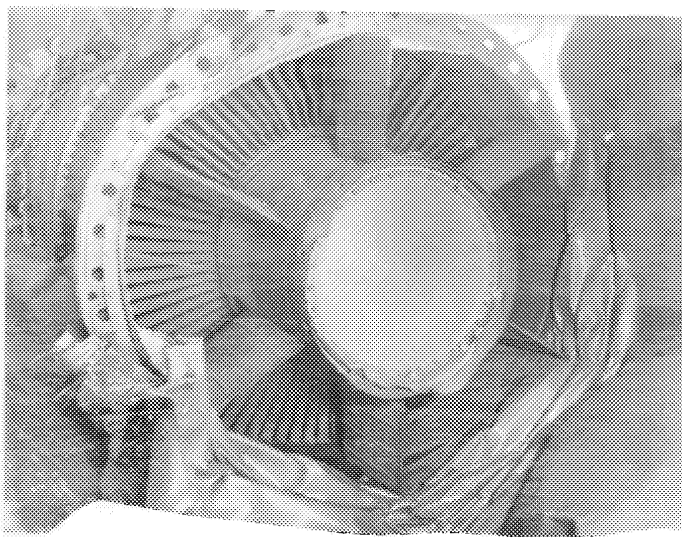
About a quarter of the third stage turbine blades are bent the opposite direction of rotation. This was caused by the entry (at impact) of a Pt7 probe into the rotating path of the third stage turbine assembly.

Summation: All of the damage to the engine occurred at the time of impact. The entire Turbine Section is intact, with the exception of three broken third stage turbine blades. These blades were broken either by the impact or by the entry of the Pt7 probe into the rotating blades. Inspection revealed no shingling of the first or third stage turbine blades.

AFT TURBINE SECTION (BOTTOM)

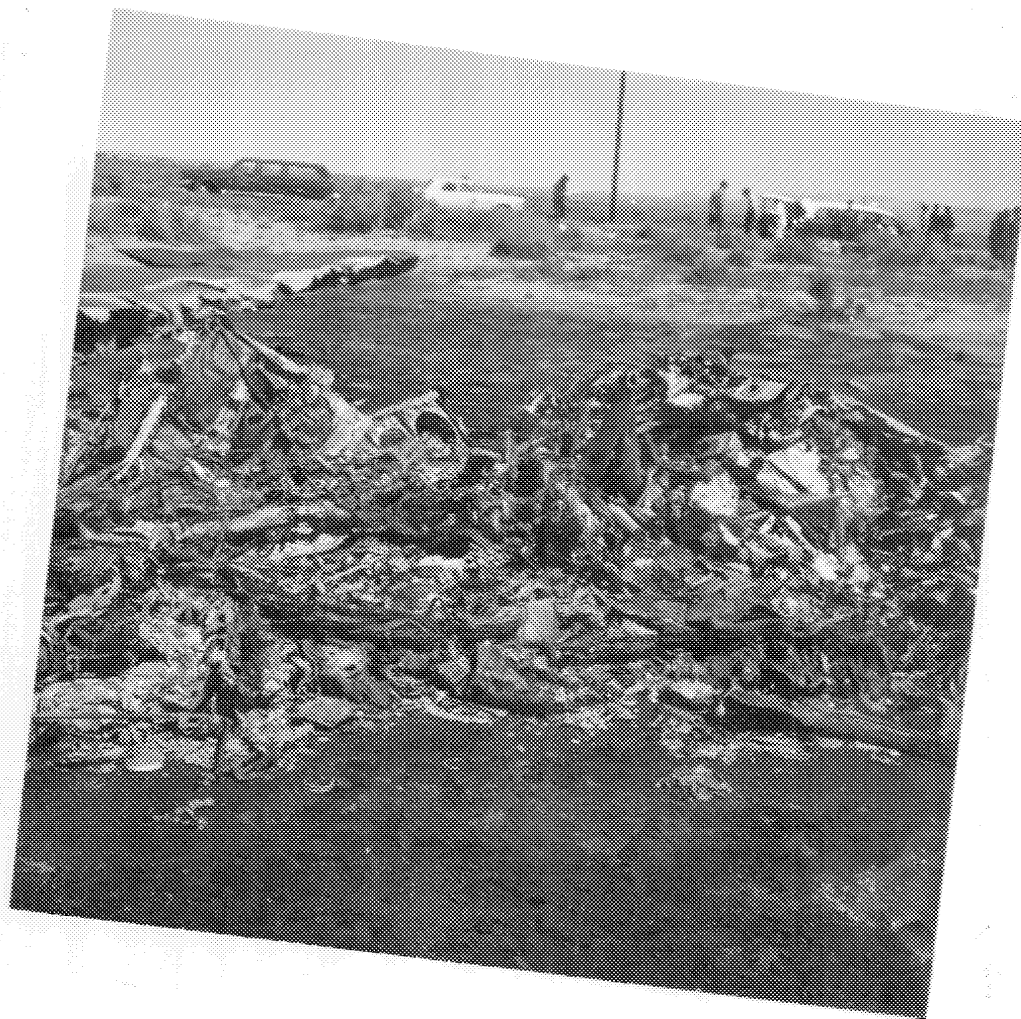
The fuselage section forward of the wing was completely gutted by fire. Both leading edges and portions of the wing where the fuel was located was also burned out by fire to various degrees. The aft fuselage was rotated to the right looking forward 90°. The fuselage severed just forward of the tail section by crushing and twisting type loads, probably on impact. The wings were pulled away from the fuselage at the root section.

NOSE, COCKPIT AND "Q" BAY AREA FIRE DAMAGE INCURRED AFTER IMPACT

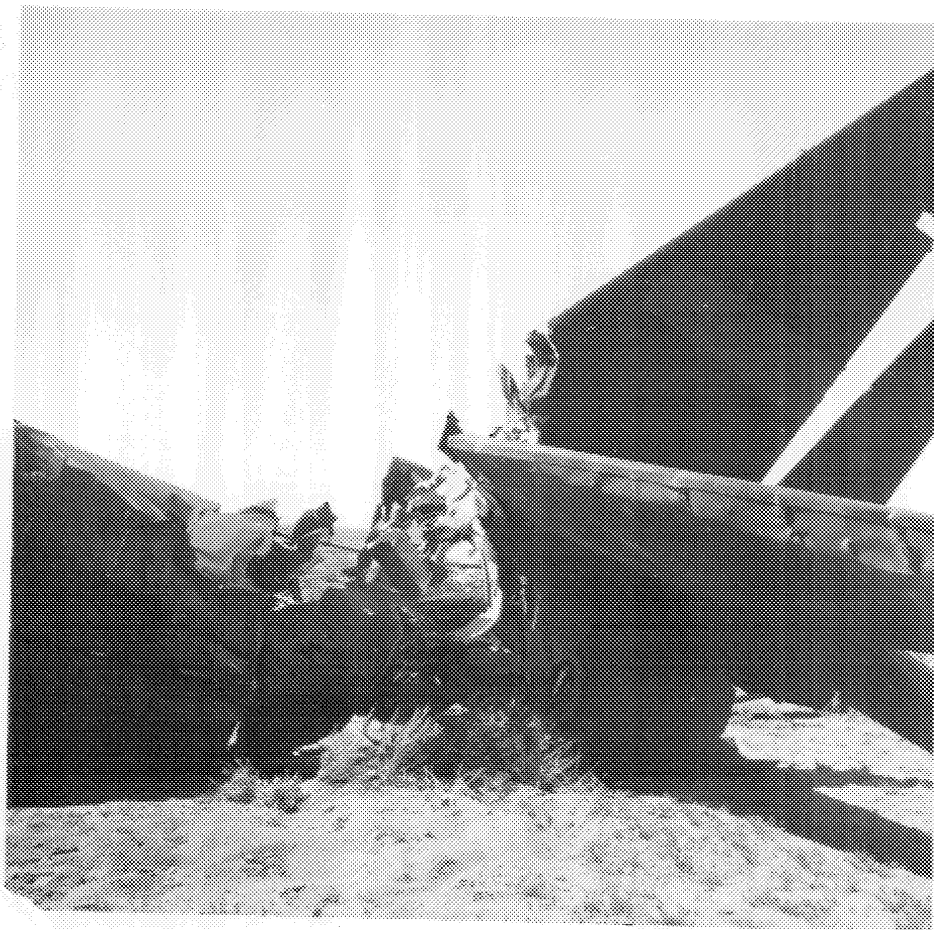
1. The aft fuselage was found rotated to the right looking forward approximately 70°. It is believed that the A/C contacted the ground L. wing and nose down and then rolled from left to right. The tail

COMPRESSION AND TWISTING OF TAIL SECTION AS RESULT OF IMPACT
